ACCIDENT INVESTIGATION REPORT  
(UNDERGROUND COAL MINE)  
NON-FATAL COAL OUTBURST ACCIDENT  
NO. 37 MINE (I.D. NO. 15-04670)  
ARCH OF KENTUCKY, INCORPORATED  
CUMBERLAND, HARLAN COUNTY, KENTUCKY

JULY 25, 1990

REPORT OF INVESTIGATION  
(UNDERGROUND COAL MINE)

NON-FATAL COAL OUTBURST ACCIDENT  
NO. 37 MINE (I.D. NO. 15-04670)  
ARCH OF KENTUCKY, INCORPORATED

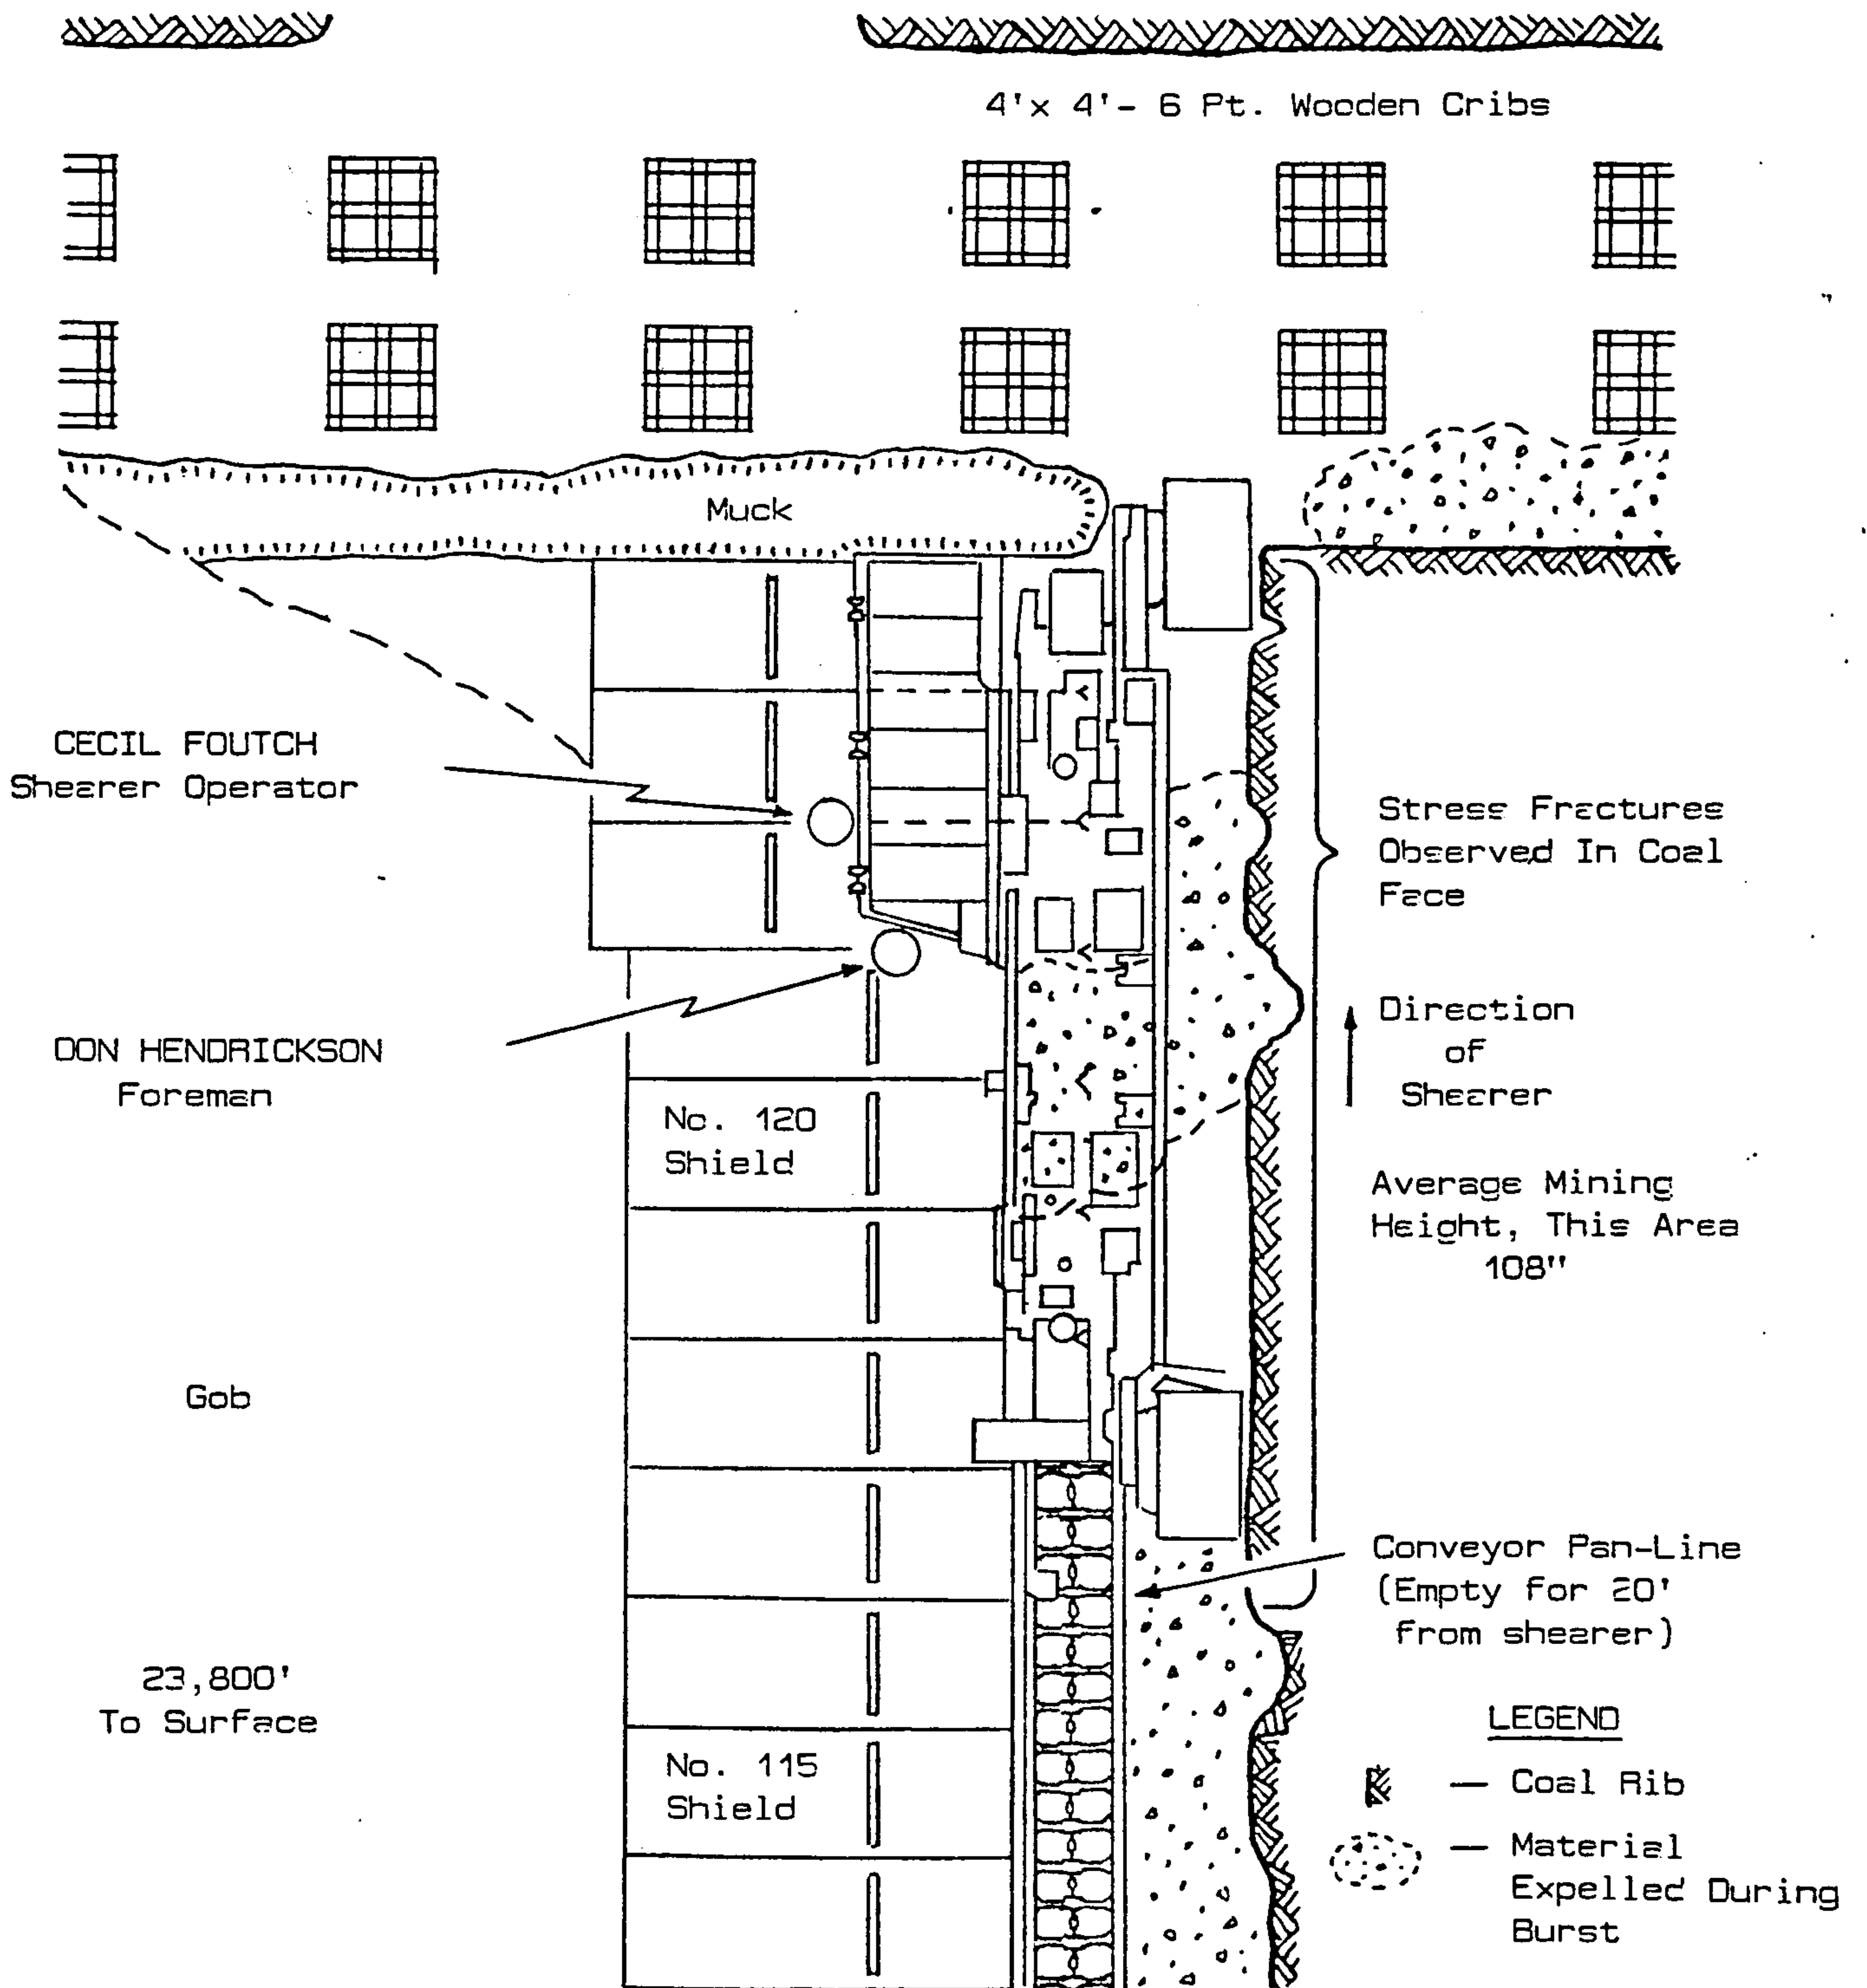
NON-INJURY COAL OUTBURST ACCIDENT  
NO. 37 MINE (I.D. NO. 15-04670)  
ARCH OF KENTUCKY, INCORPORATED  
CUMBERLAND, HARLAN COUNTY, KENTUCKY  
JULY 25, 1990

At 12:23 p.m., Wednesday, July 25, 1990, a noninjury coal outburst accident occurred on the longwall face of the 004 (G-2) section. The burst involved approximately 190 feet of the face from the Nos. 86 to 124 shields (tailgate). Material was also expelled from the longwall rib-line in the tailgate for a distance of approximately 100 feet outby the face. No personal injuries were reported, however, the shearer was moderately damaged.

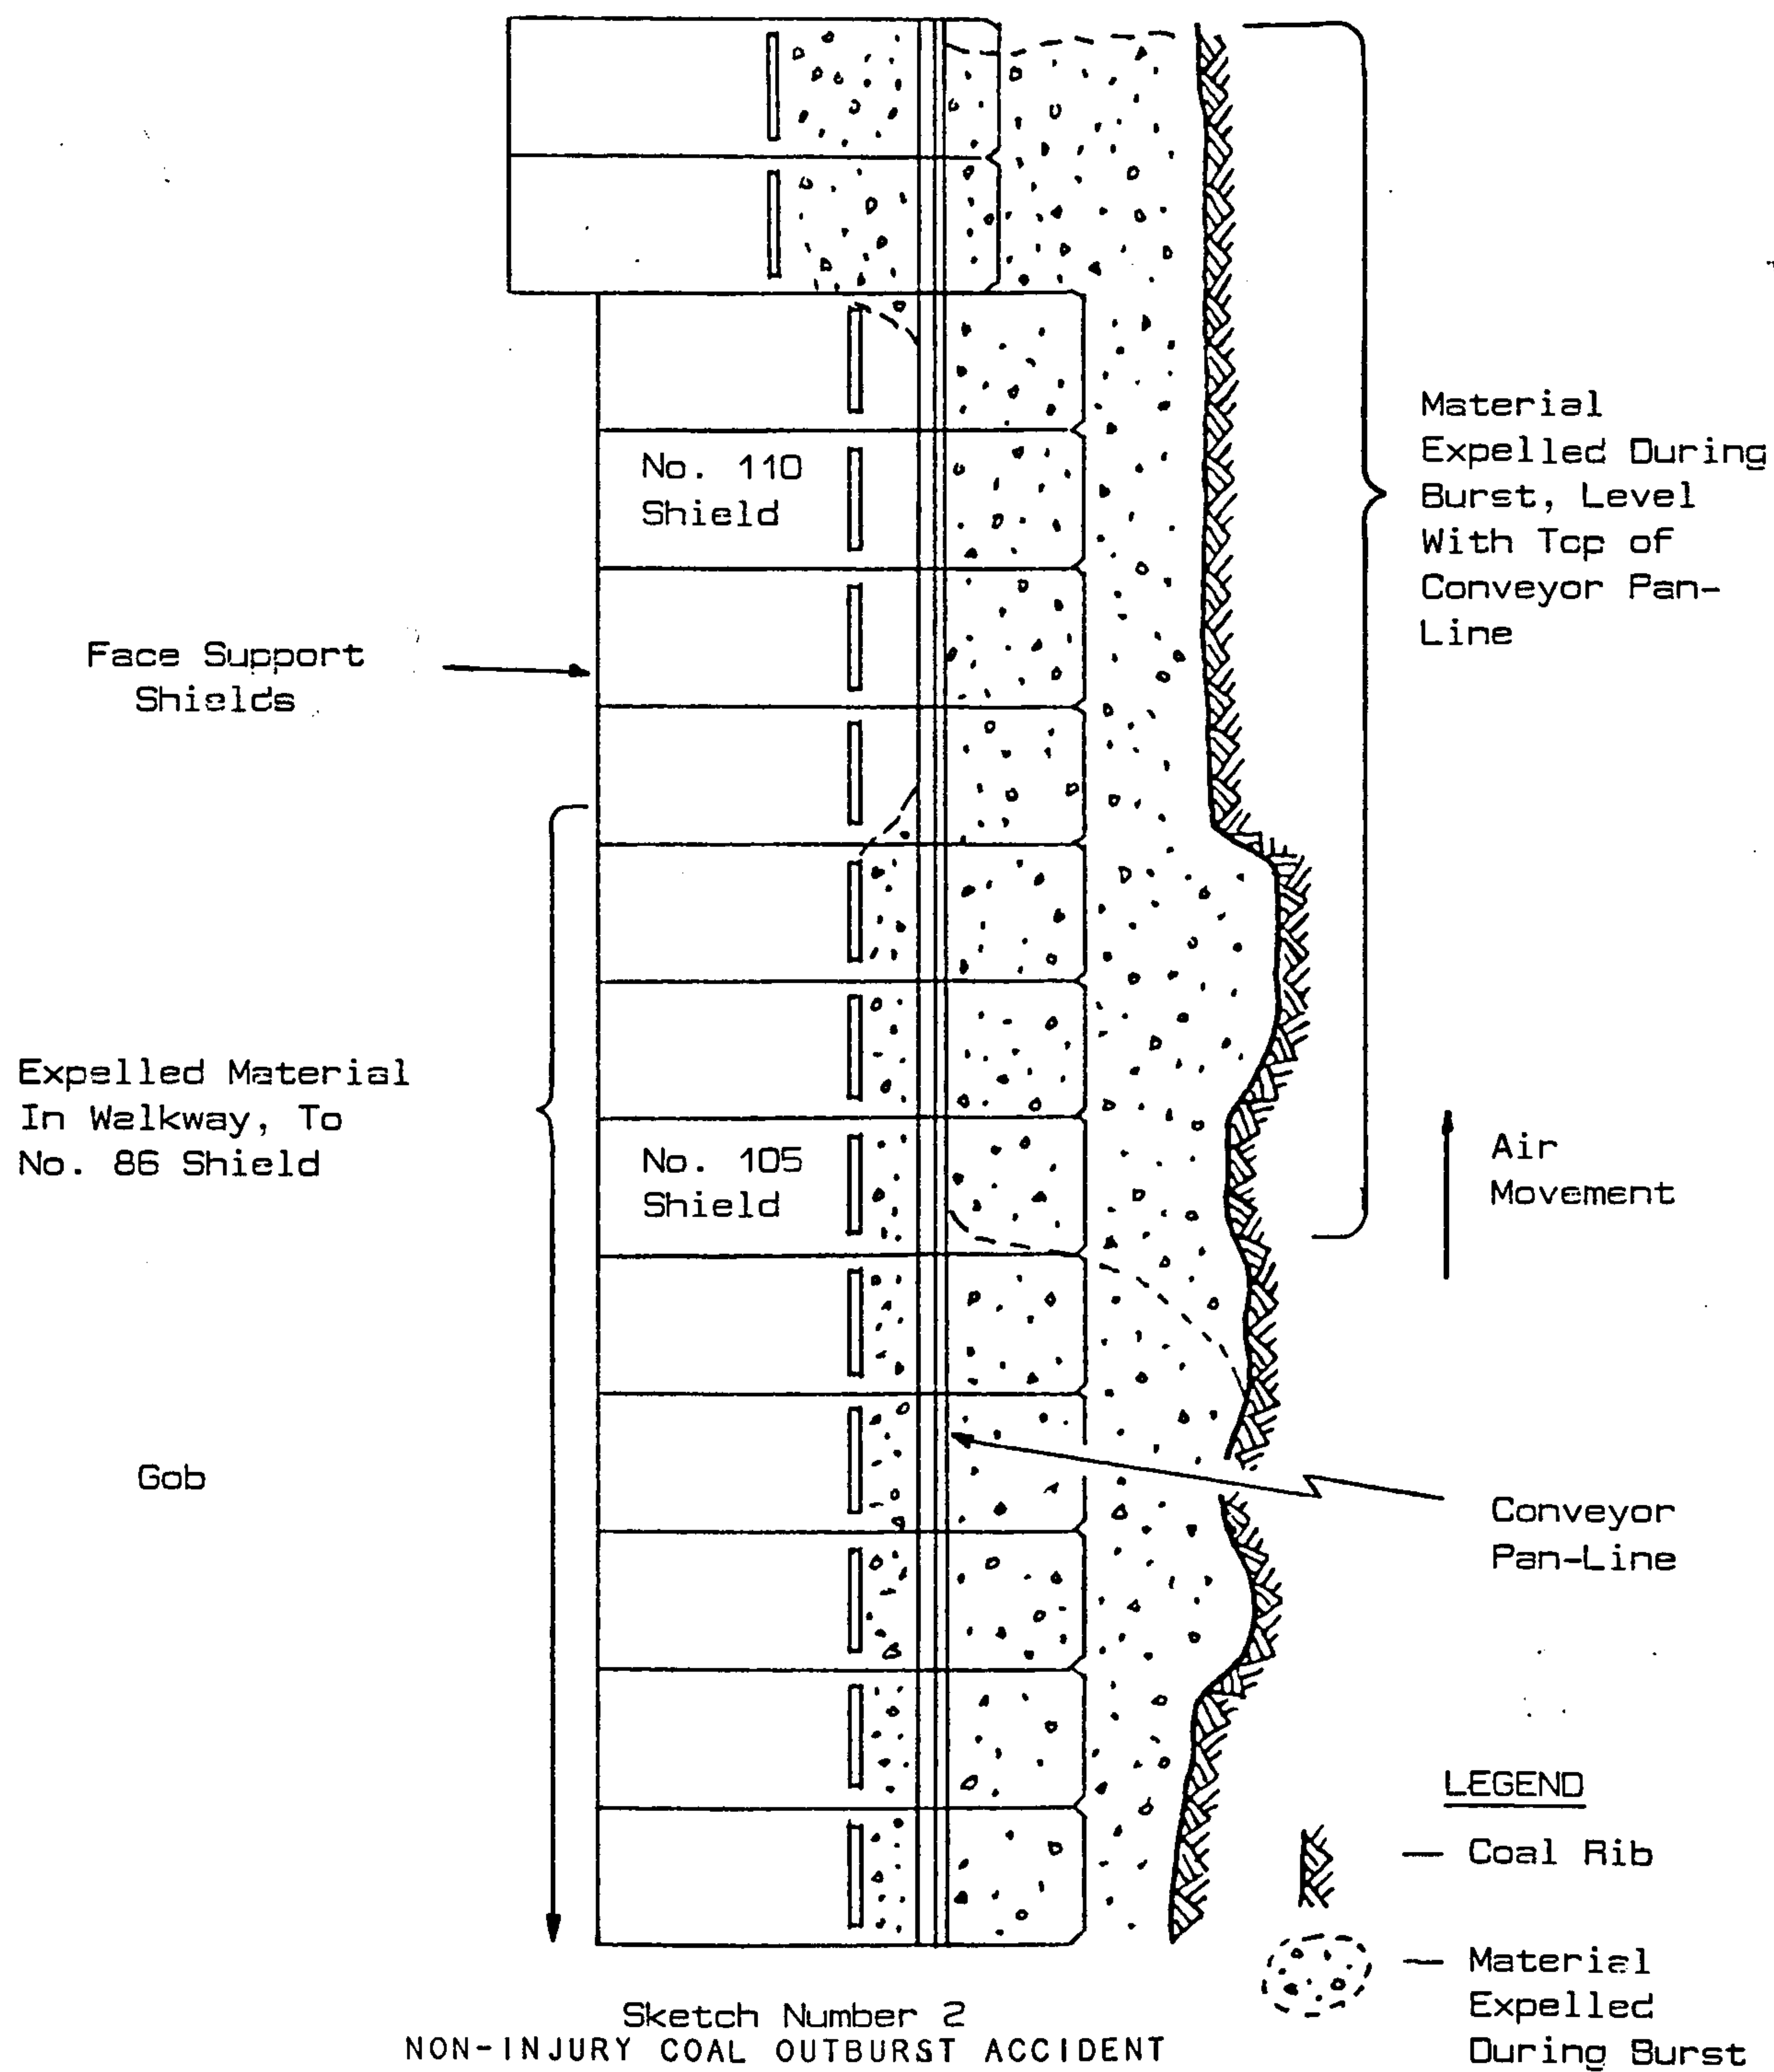
Sketch Number 2  
 NON-INJURY COAL OUTBURST ACCIDENT  
 NO. 37 MINE (I.D. NO. 15-04670)  
 ARCH OF KENTUCKY, INCORPORATED  
 CUMBERLAND, HARLAN COUNTY, KENTUCKY  
 JULY 25, 1990

10. Approximately seventy tons of material was dislodged from the coal face. Moderate amounts of material was expelled from the coal face into the walkway and support shields, to depths up to six inches, from the number eighty-six shield to the number one-hundred fifteen shield. Material, in depths to four feet filled the conveyor pan-line from the number one-hundred shield to the number one-hundred thirteen shield.

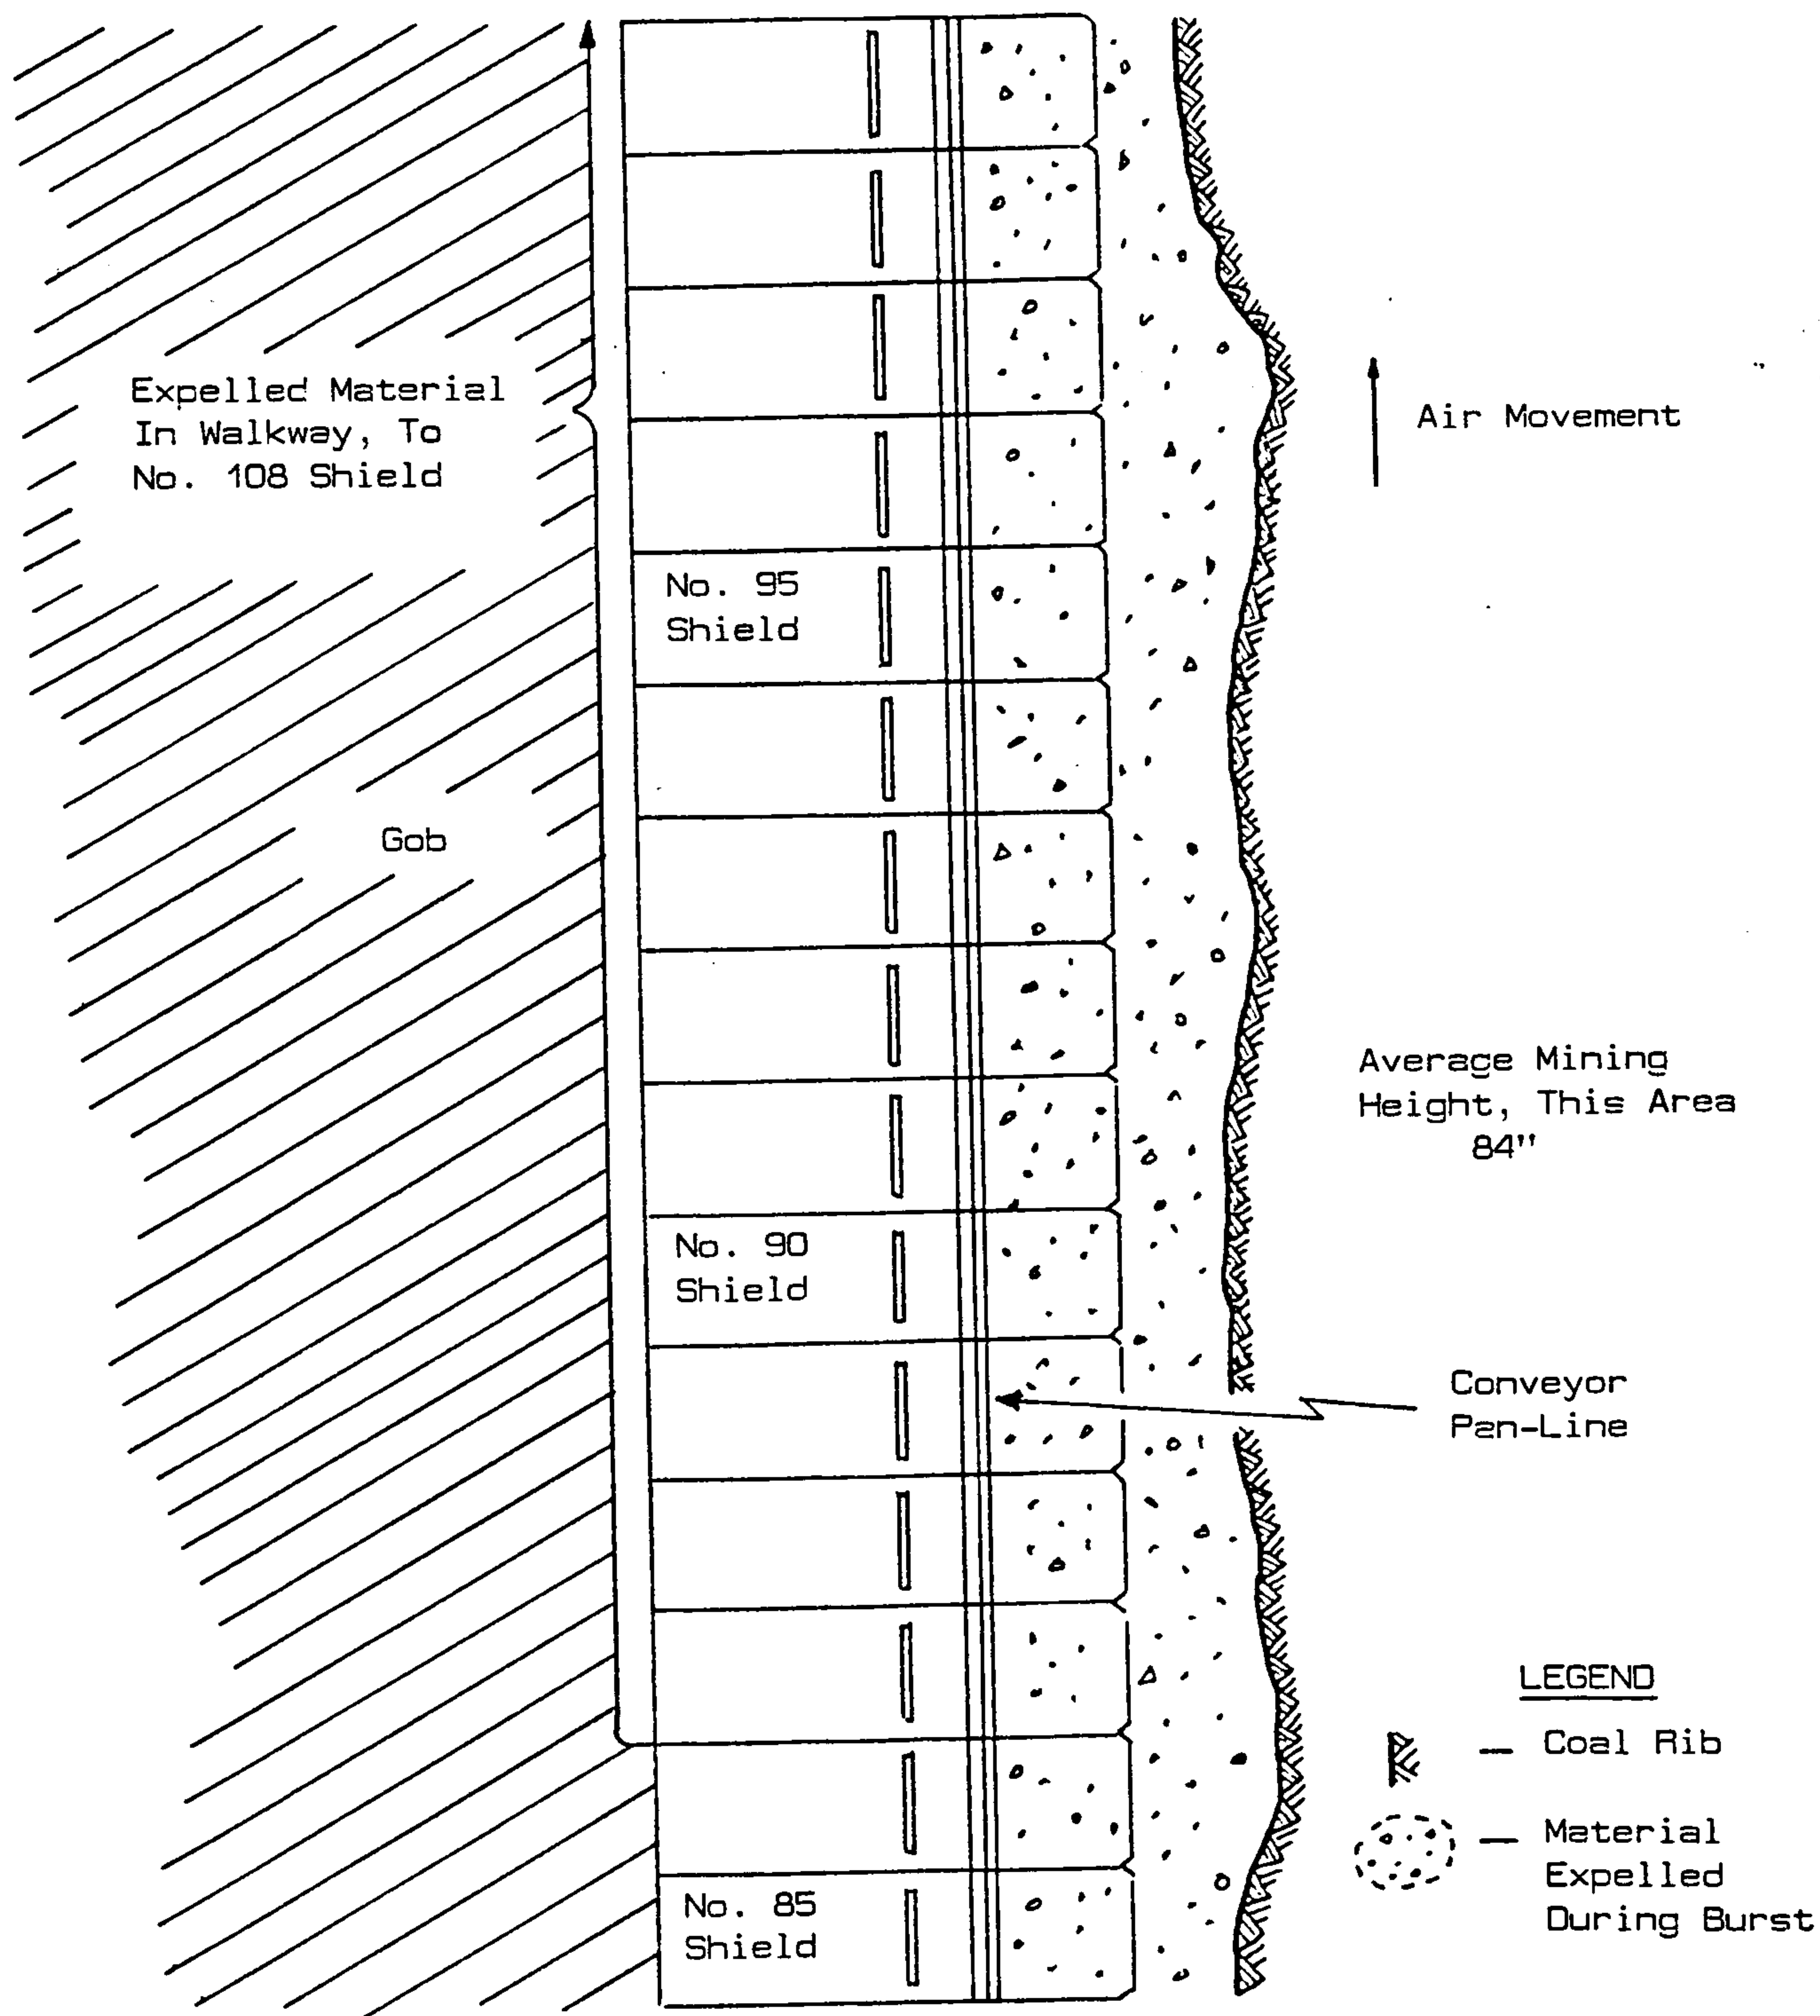
Sketch Number 3  
 NON-INJURY COAL OUTBURST ACCIDENT  
 NO. 37 MINE (I.D. NO. 15-04670)  
 ARCH OF KENTUCKY, INCORPORATED  
 CUMBERLAND, HARLAN COUNTY, KENTUCKY  
 JULY 25, 1990

14. The face support advance rams on the number one-hundred to number one-hundred twenty-one shields showed signs of being over pressurized and lateral movement of up to ten inches. The pressure relief valves, set at five-thousand pounds per square inch, showed accumulations of hydraulic emulsion on the vent part of the relief valves.

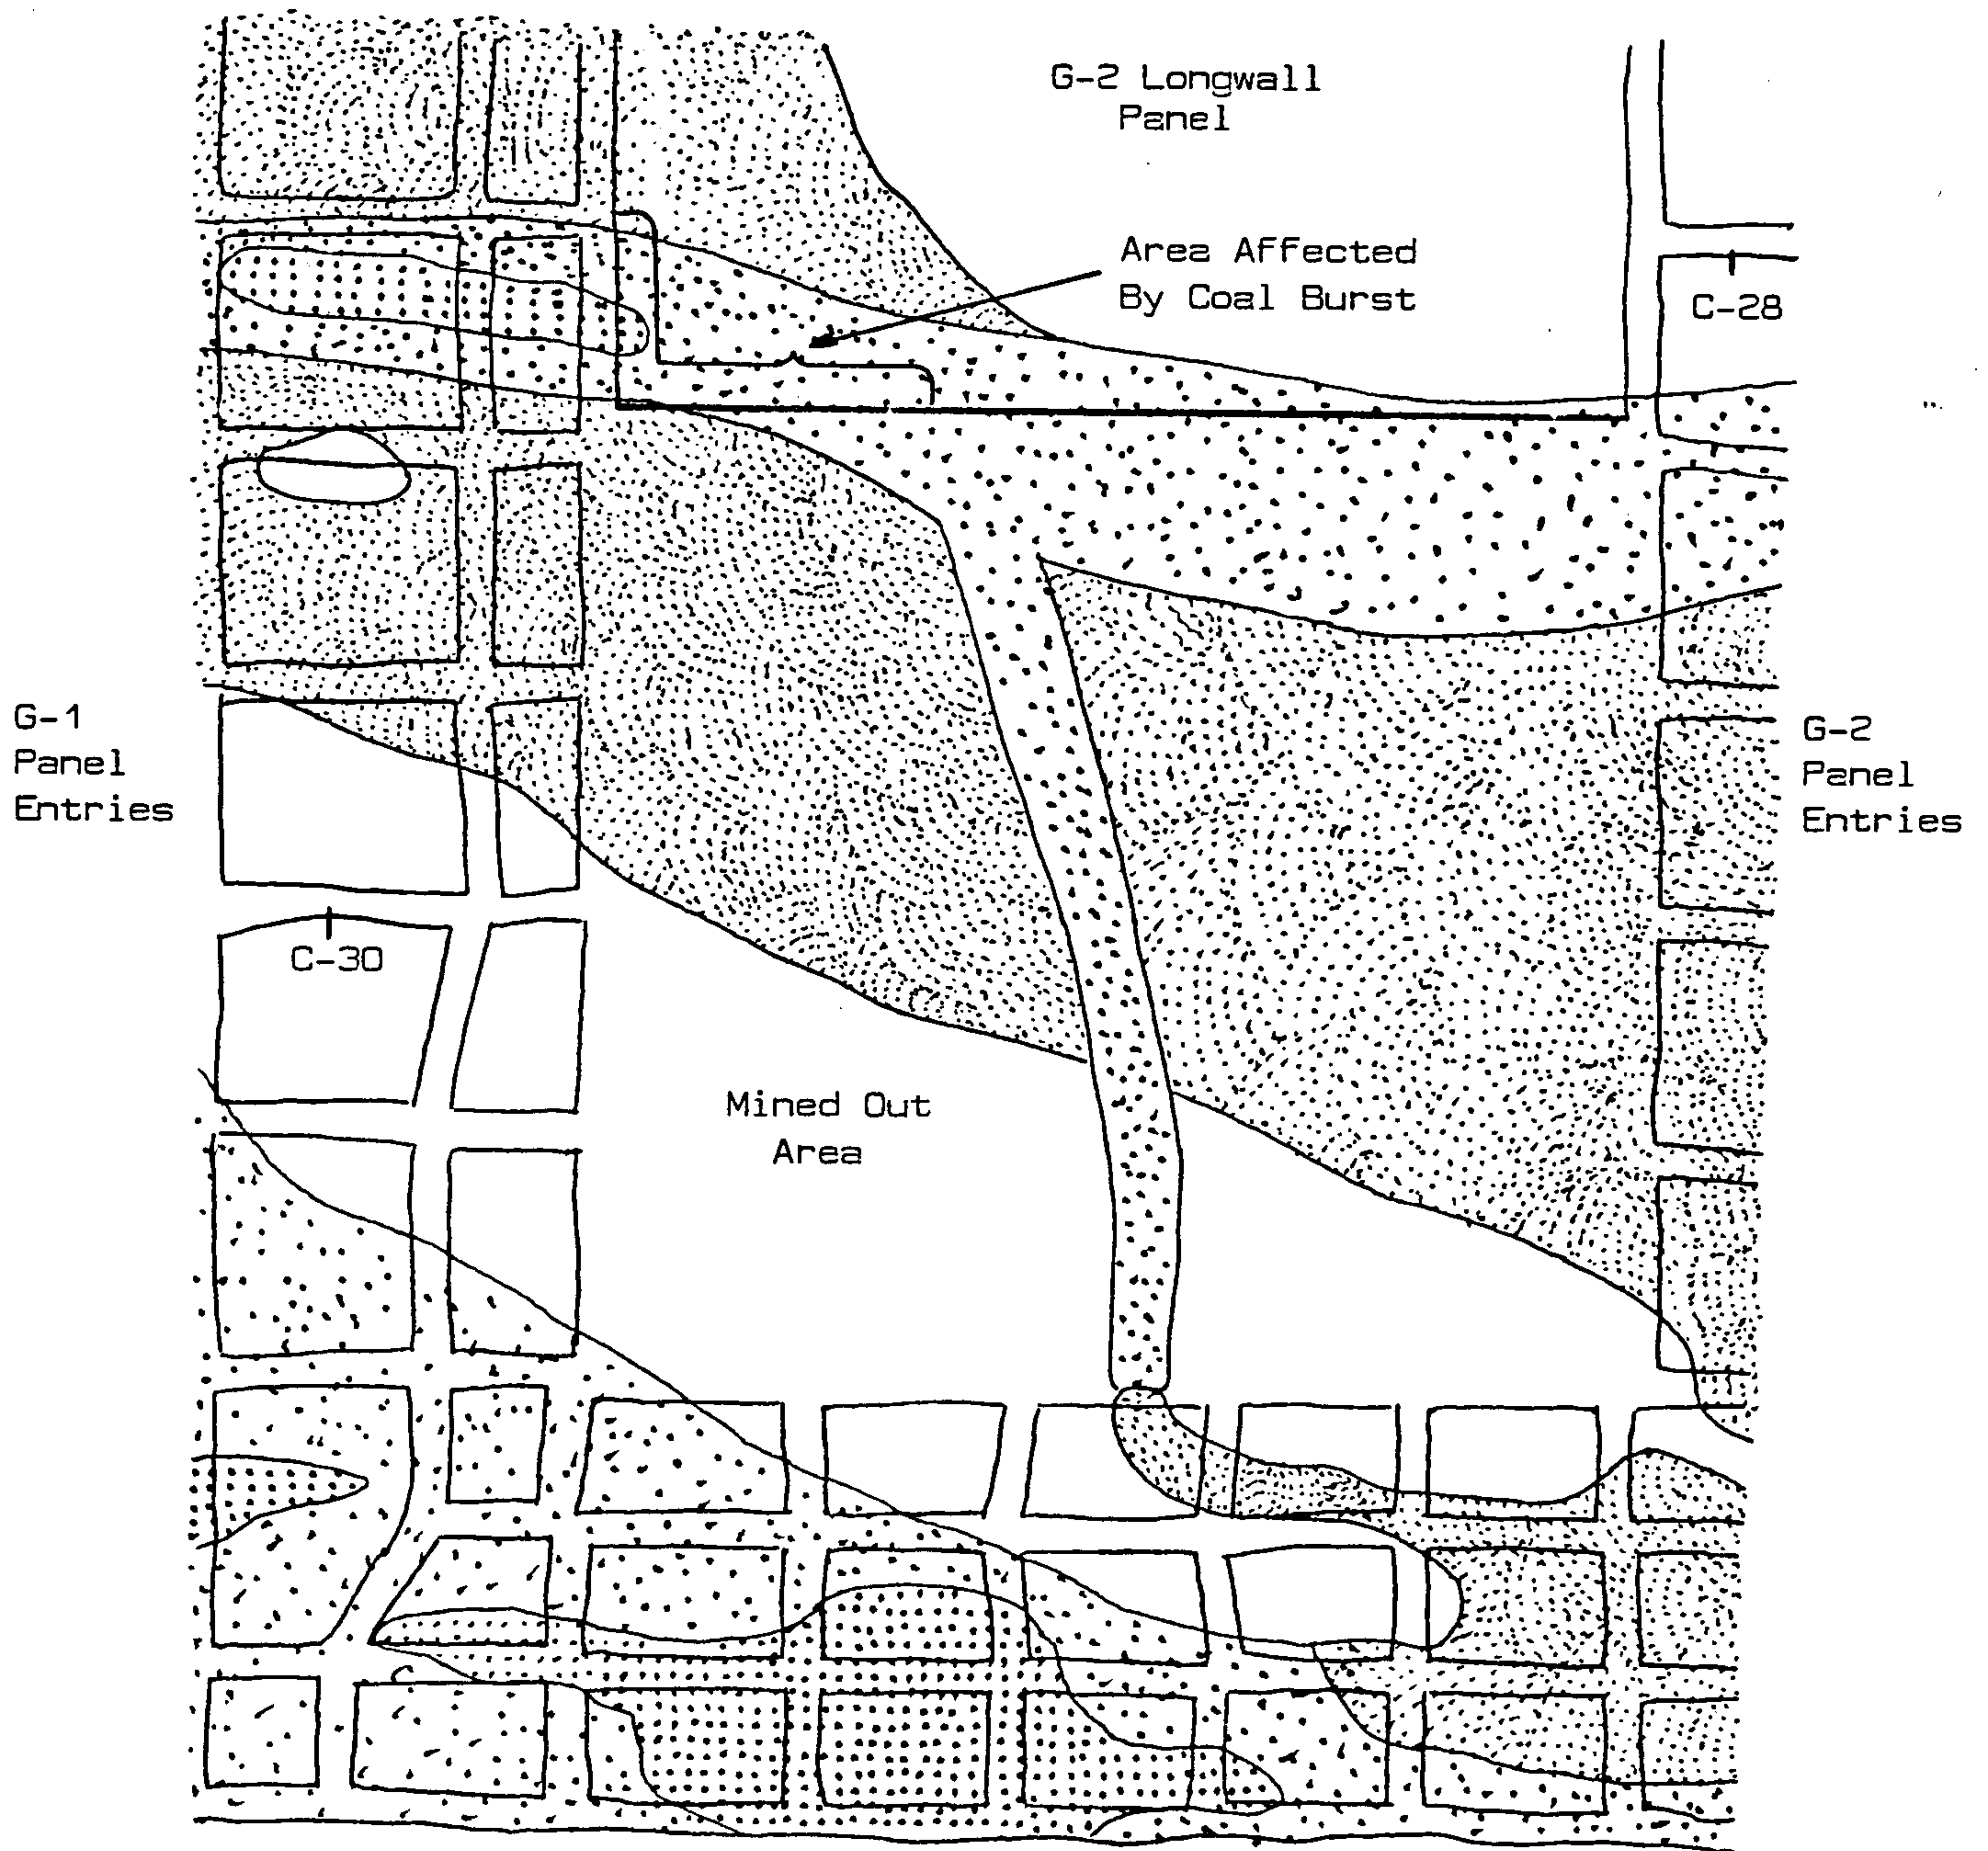
Sketch Number 4

The accident occurred due to excessive pressure at the tailgate end of the working face, created by approximately two-thousand feet of overburden and a sandstone chanrel anomaly. A contributing factor to the occurrence was the de-stressing hole drilled into the coal rib, tailgate side, not being pressurized and did not aid in relieving stress on the coal face.

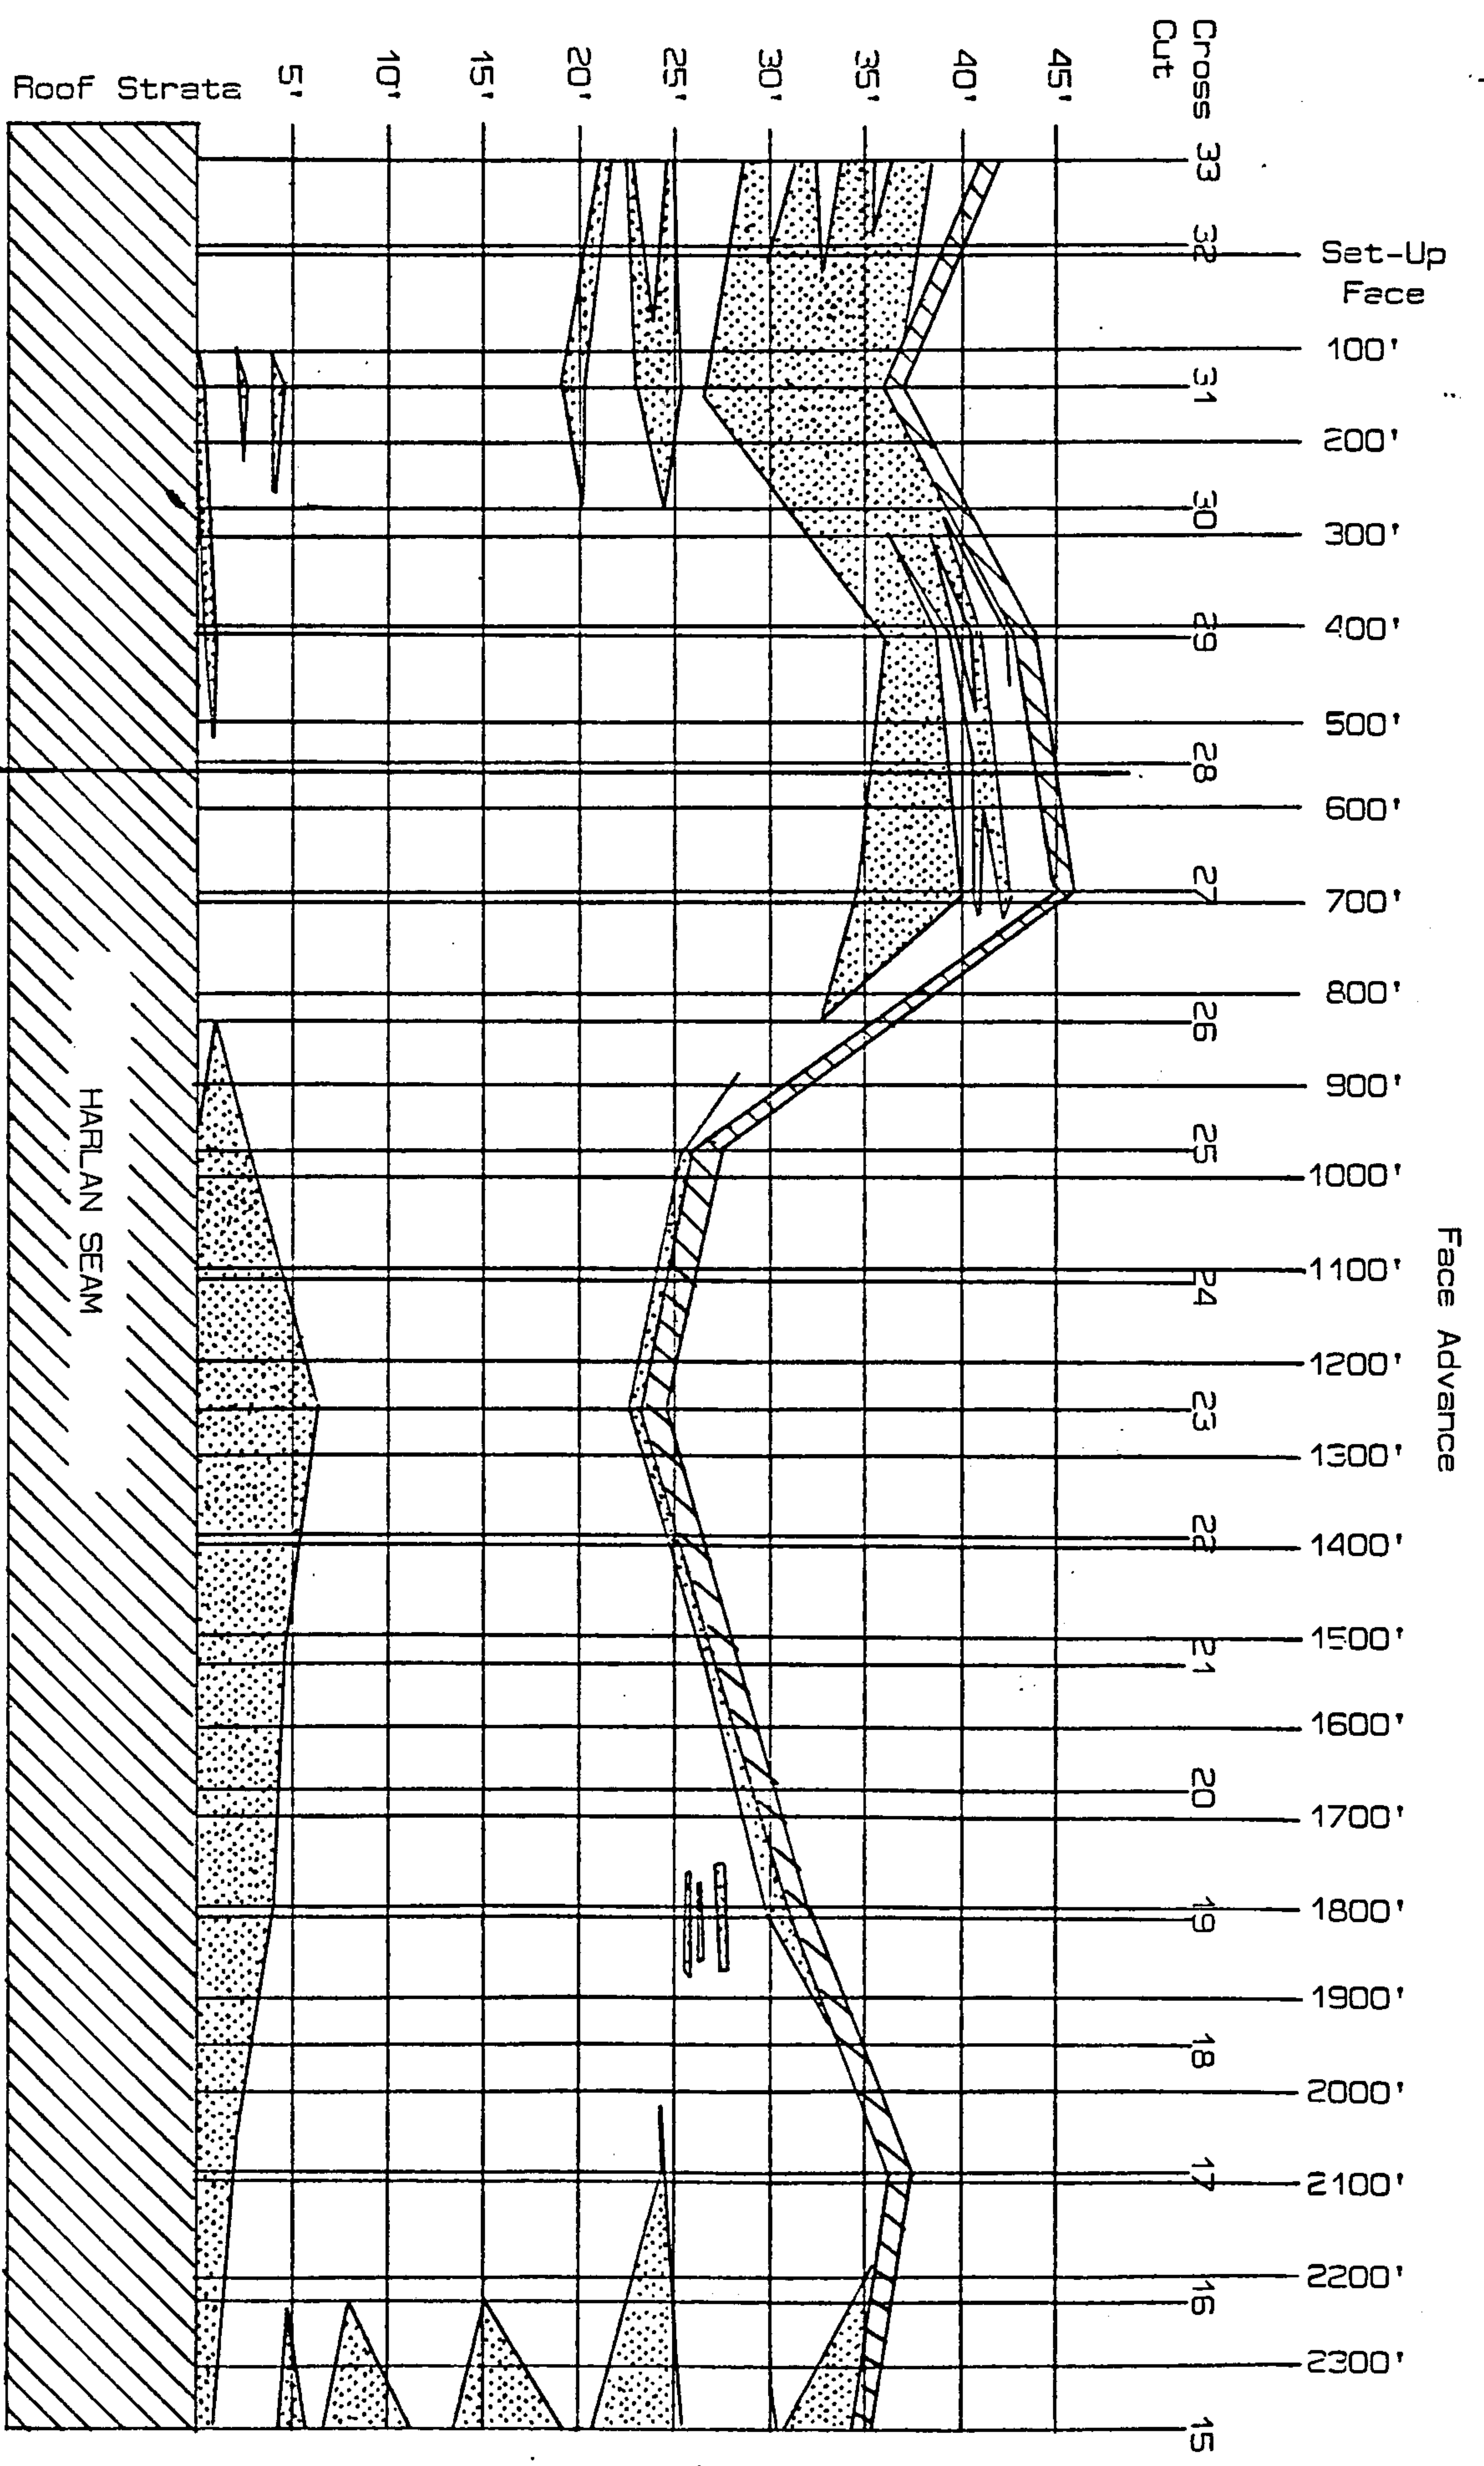
Stratigraphic CAD Drawing

9. The immediate roof in the affected area was thirty-five feet sandstone.
